**Hurricane Damage Assessment:**  
***Lessons Learned from Hurricane Katrina***

James W. Jordan, SE, PE, M.ASCE<sup>1</sup>

Saul L. Paulius, SE, PE, M.ASCE<sup>2</sup>

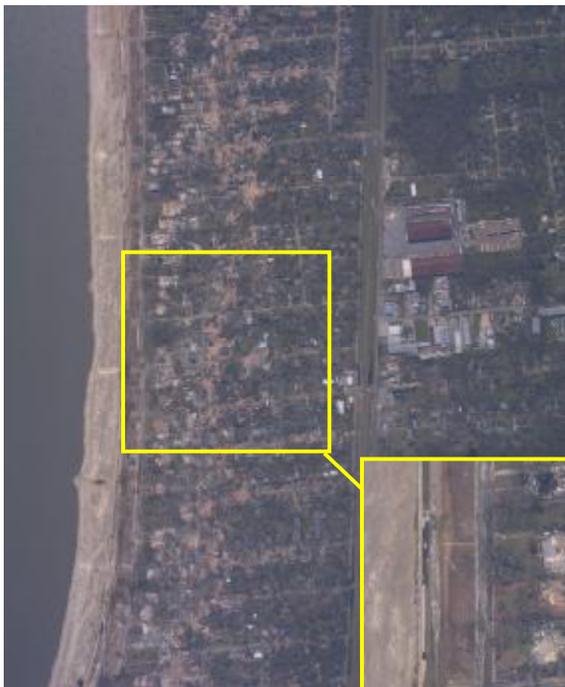
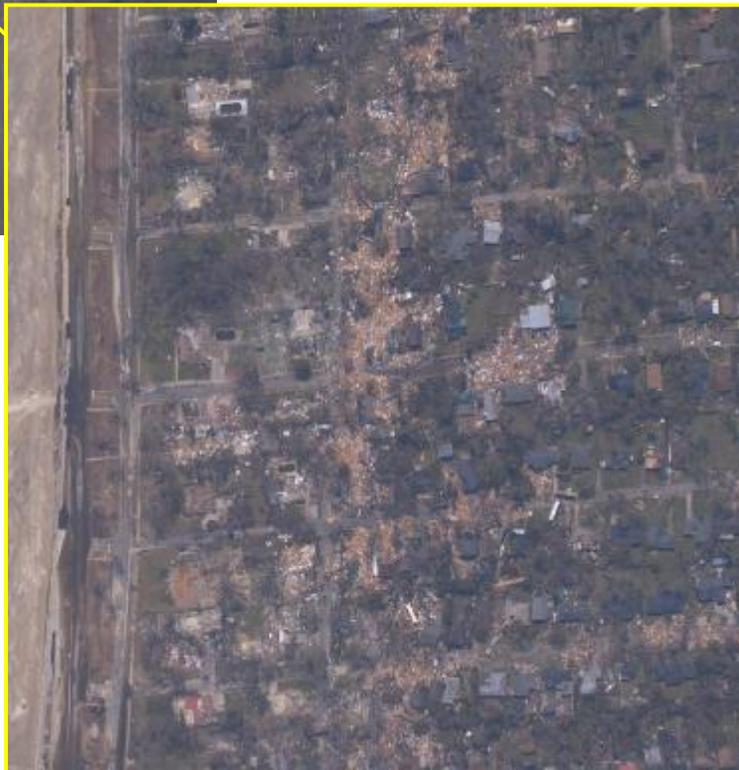
**Figure 4: Aerial photographs of damages near Gulfport, Mississippi after Hurricane Katrina [provided by NOAA]. Note the difference in damages in buildings on either side of the debris field. The debris field was created by the storm surge, and those structures impacted by the storm surge were essentially destroyed, whereas buildings inland from the storm surge remained intact.**

A tremendous amount of information became available for those assessing Hurricane Katrina damage. Of particular value were aerial photographs of the hurricane damaged areas published by NOAA<sup>3</sup> [see Figure 4]. Other valuable resources included weather data from a variety of sources, United States Geological Survey (USGS) topographic maps<sup>5</sup>, and aerial photographs taken prior to the hurricane. The use of these resources to supplement on-site observations provided structural engineers with the means to determine damages caused by high winds versus the storm surge. These resources were available free of charge on the internet. Forensic meteorologists were also available to provide weather information and opinions on the chronology of the wind and surge components of the hurricane.

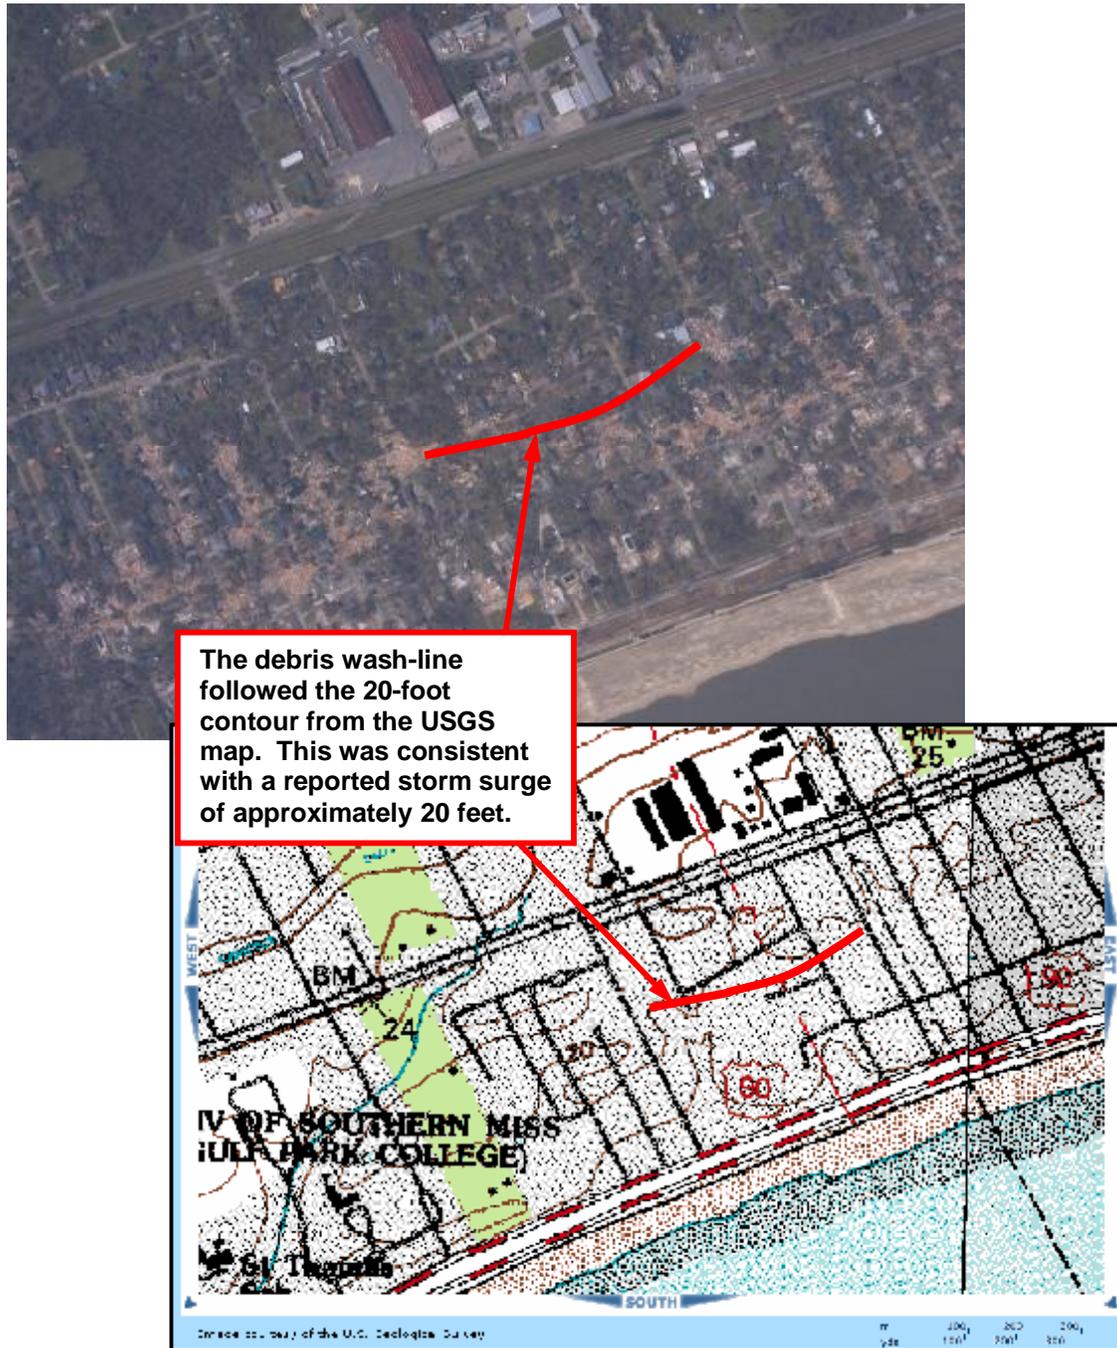
Figure 5: By orienting the NOAA aerial damage photograph from Figure 5 and comparing to a USGS topographic map of the area, the storm surge height may be estimated by examining the location of the debris wash-line.

In most areas along the Mississippi coast line, a distinct debris field was evident near the beachfront. By comparing the outer edges of the debris field with topographic maps, one could estimate the storm surge height – or at least provide an approximate confirmation of reported surge estimates [see Figure 5]. In addition, a Federal Emergency Management Agency (FEMA) website<sup>8</sup> provided reference maps that showed the estimated inland extent of the storm surge.

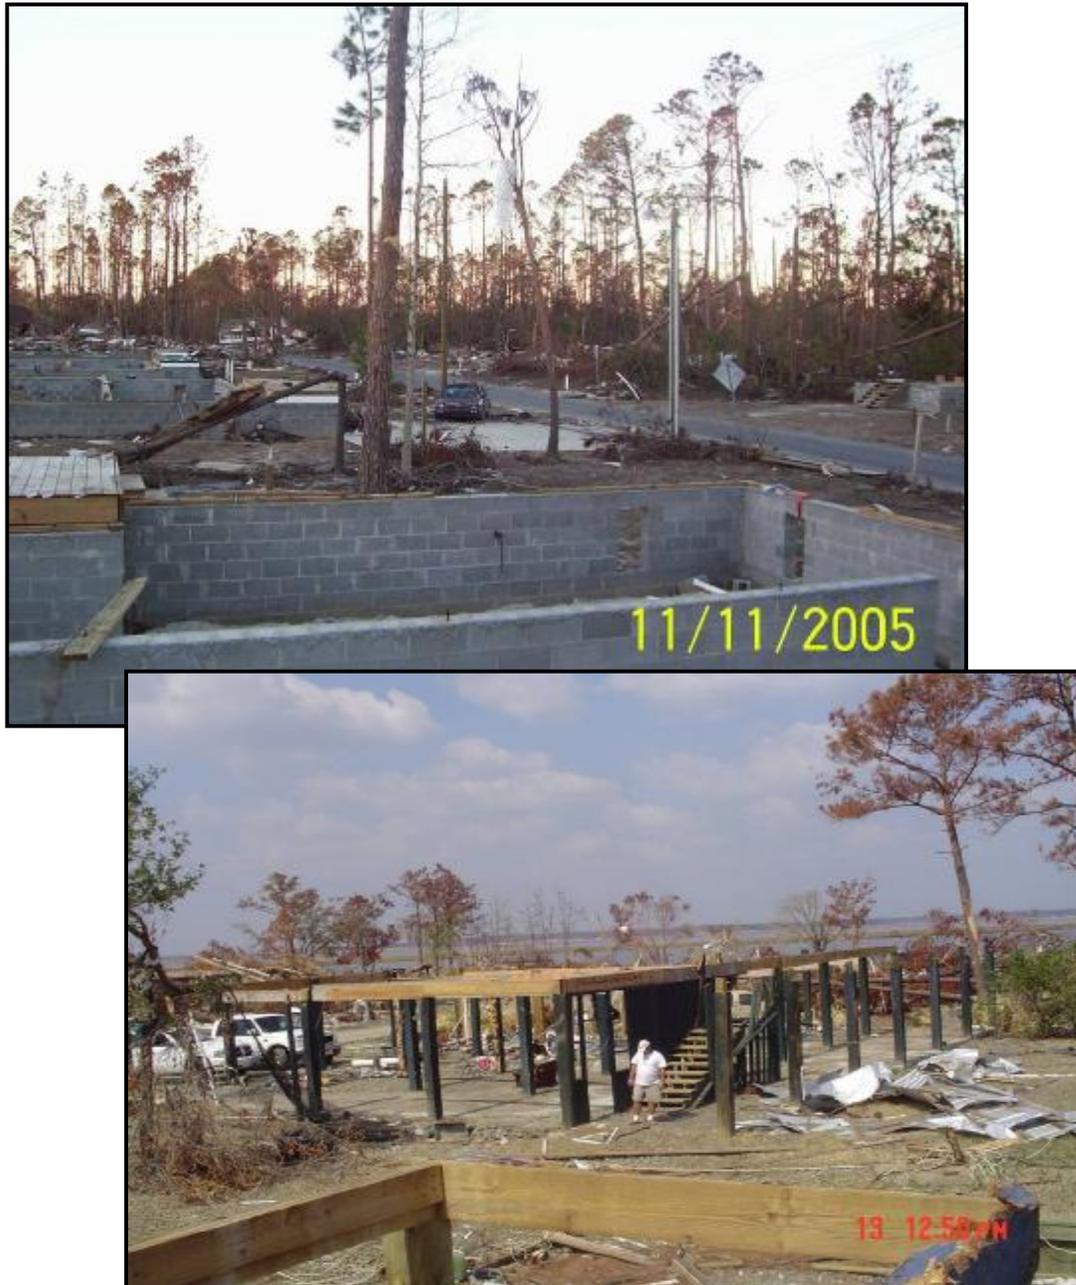
**Figure 6: Typical views of devastation along the Mississippi coast caused by Hurricane Katrina. Determining the extent of wind damages prior to the storm surge sweeping through these sites was a daunting task for the structural engineer.**

In some coastal neighborhoods, all of the visible building superstructures were destroyed. A structural engineer assessing a distinction of damages caused by high winds before the storm surge swept through the site had a very daunting task. Without the aid of the aforementioned resources, an opinion regarding the extent of the likely wind damages was difficult (if not impossible) to substantiate. Figure 6 shows some of the typical views along the areas with the most severe damage.

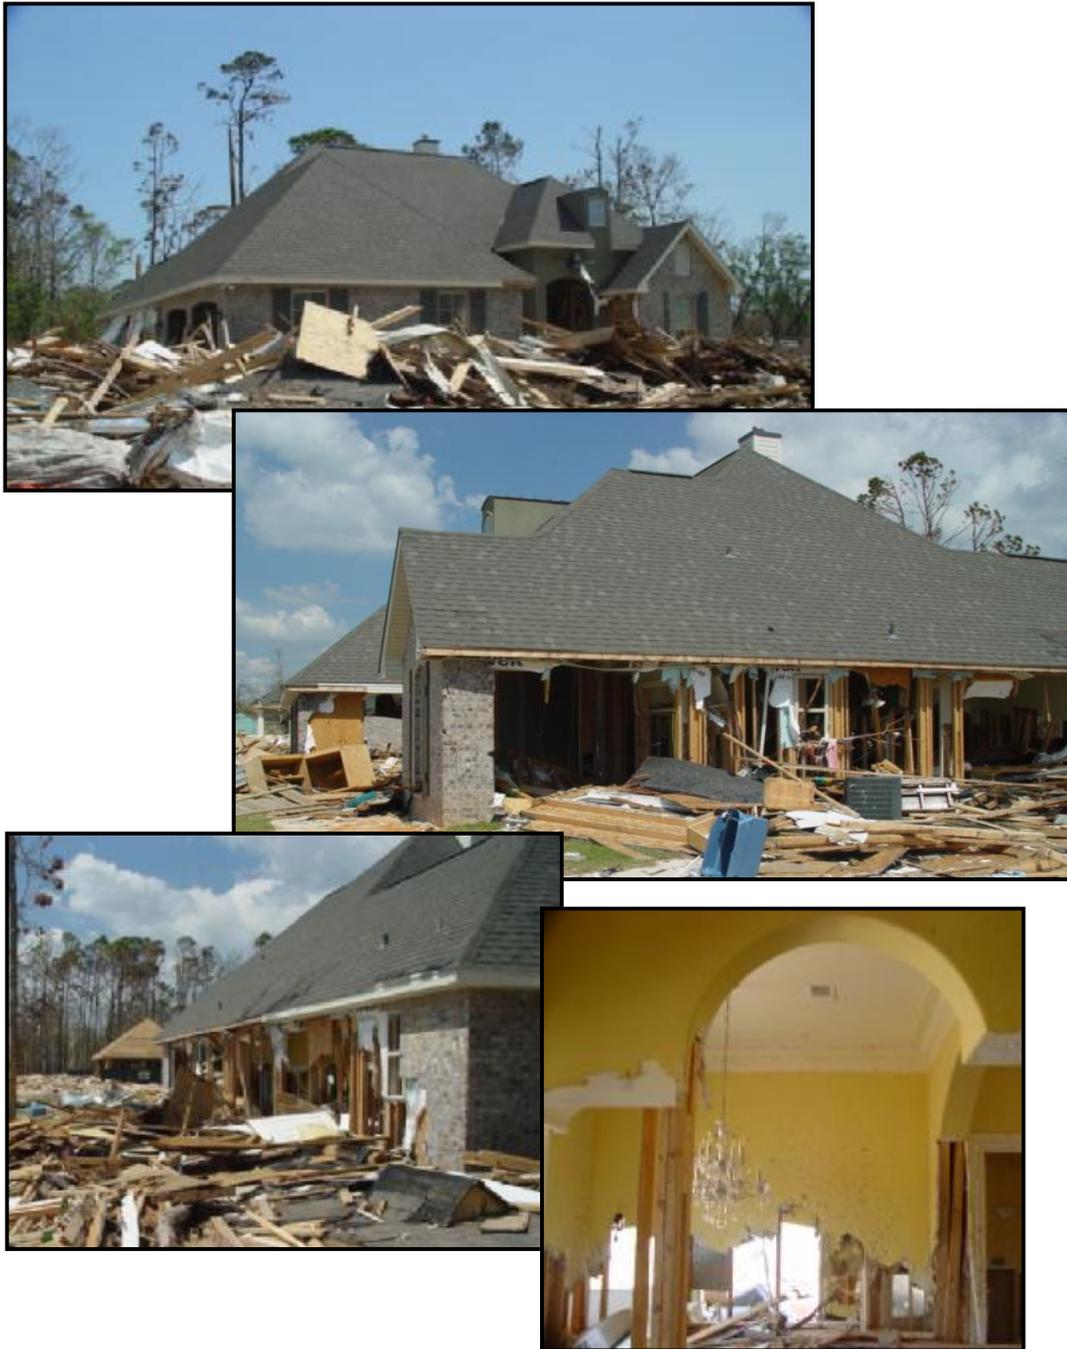
## Case Study 2: Wood-Framed, Single-Family House in Long Beach

The storm surge reached a height of about 10-feet at this site, and caused the destruction of the south exterior wall (facing the beach). The severity of damage was greatest at the first story, consistent with the destructive forces of the storm surge. Relatively minor damage to the roof covering was the extent of wind damages found at this structure.

**Figure 8: Series of photographs that documented damages to the house. Note that minimal damage was present to the roof covering, while severe damages were on the lower part of the structure. This was a good example of typical damages caused by the storm surge from Hurricane Katrina.**

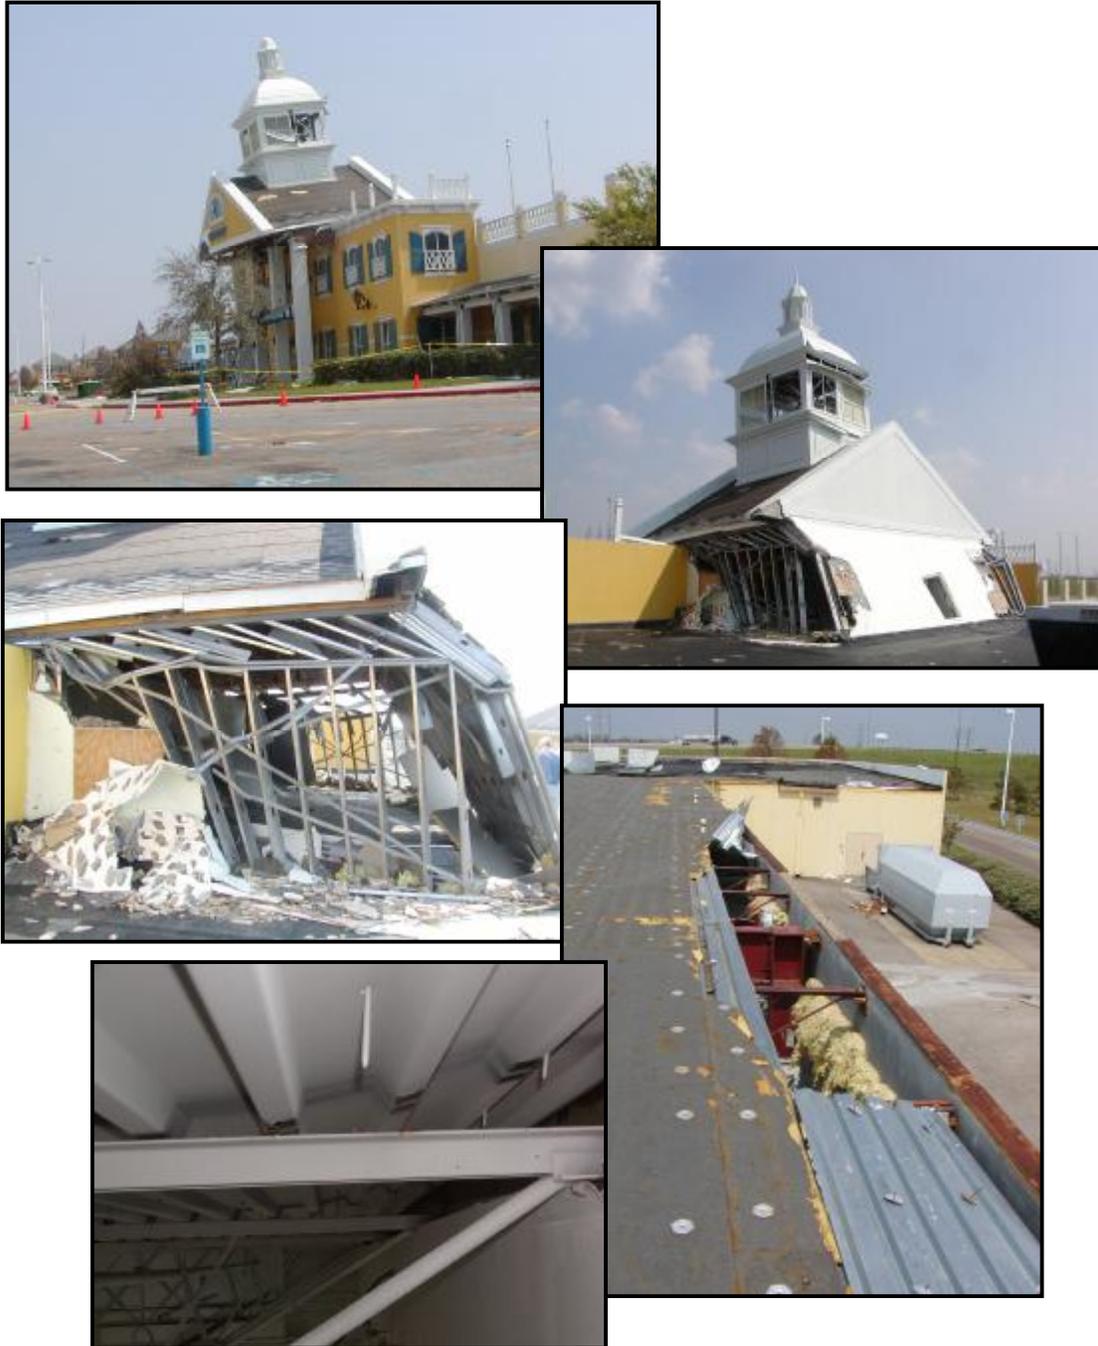
#### Case Study 4: Steel and Precast Concrete Shopping Mall in Gulfport

The storm surge did not reach this site, thus the storm damage was caused by high winds. Wind gusts of 132 mph were estimated in Gulfport. Damages to these buildings included localized portions of missing metal roof deck, removal of about half of the membrane roof covering, and the collapse of an elevated roof structure.

**Figure 10: Series of photographs that documented damages to the shopping mall. The partial collapse of the elevated roof structure was attributed to construction defects (inadequate bracing / unstable construction) whereas the removal of localized portions of roof deck occurred at the perimeter due to the failure of puddle welds.**

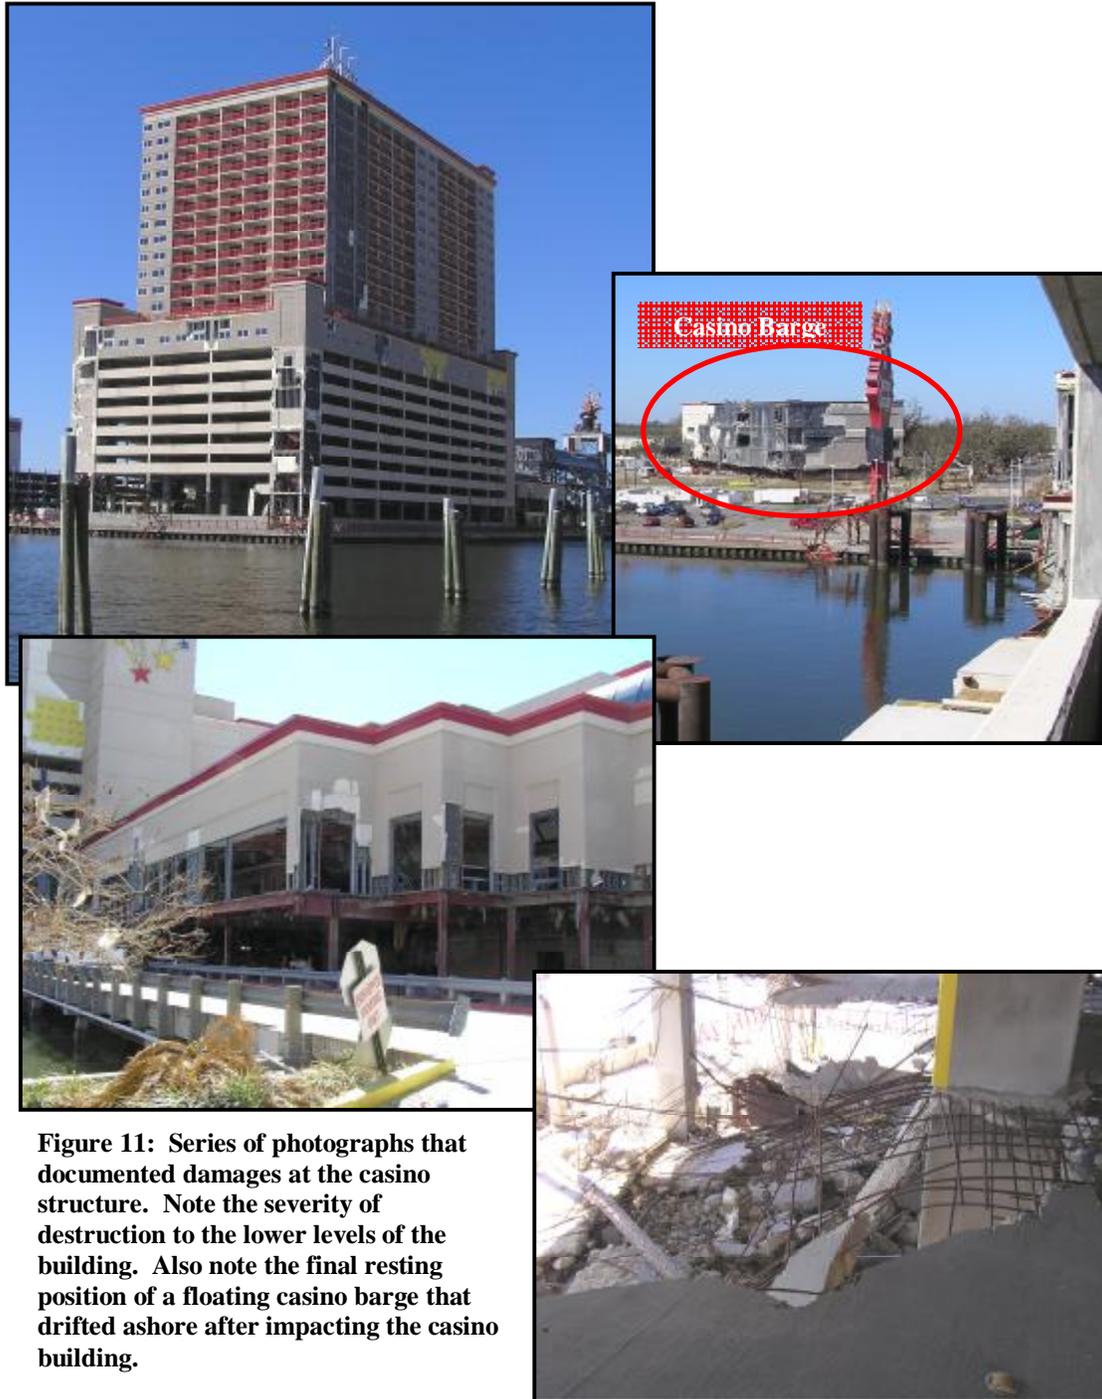
### Case Study 5: Steel and Concrete Casino in Biloxi

The storm surge reached a height of about 25-feet at the site, and caused severe damages to all of the first and second story walls and finishes. Waves from the storm surge caused a floating casino structure to break from its moorings and batter the building as it drifted ashore. There was finish damage caused by the wind to the portions of the structure above the second floor.

**Figure 11: Series of photographs that documented damages at the casino structure. Note the severity of destruction to the lower levels of the building. Also note the final resting position of a floating casino barge that drifted ashore after impacting the casino building.**
